# *RND Home Inspections, LLC.*

## Property Inspection Report

1234 RND Home Inspection Way, Malibu, CA 90265

General, pool, and sewer inspection

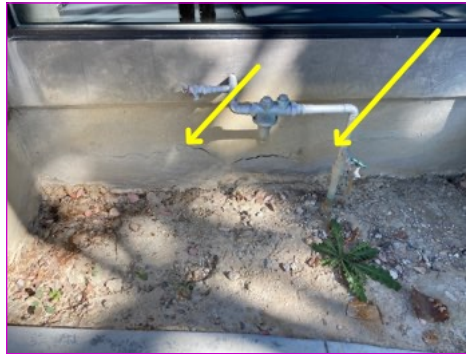
- Cracks and deterioration noted at the front foundation large coat. The damage is likely caused by excessive amounts of moisture in the soils due to a lack of drainage. We recommend having a qualified contractor evaluate and repair as needed.

*Cracks and deterioration noted at the front foundation large coat.*

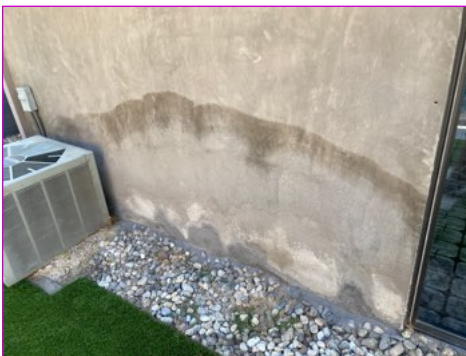
- Stucco damaged at the rear left wall. Stucco is deteriorating and falling off wall. We recommend having a qualified contractor evaluate and repair as needed.

*Stucco damaged at the rear left wall.*

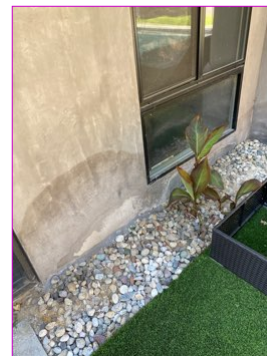
*Stucco damaged at the rear wall*

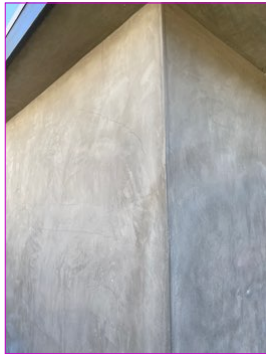
• The stucco covering exterior walls showed widespread moderate cracking. This type of cracking, called "thermal cracking" is a reaction to internal stresses created by stucco expansion and contraction caused by daily and seasonal temperature changes. This condition is made worse over time by exposure to moisture. Cracks exceeding 1/16-inch in width should be filled with an appropriate material to minimize future damage. Thermal cracking is common as stucco ages and minor cracks are a cosmetic concern. This type of cracking can be expected to continue slowly over time.

*Stucco cracking noted at the front left wall*

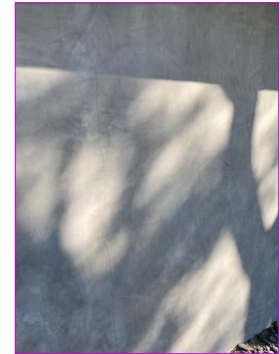
*Cracks in exterior wall*

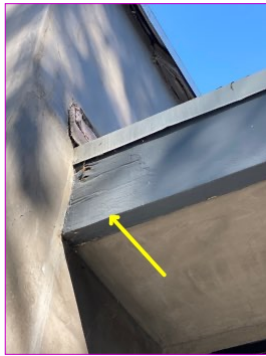
• At the time of the inspection, home fascia showed moderate weathering and deterioration commensurate with its age. We recommend having a qualified contractor repair as needed.

Moisture damage noted at front fascia boards.

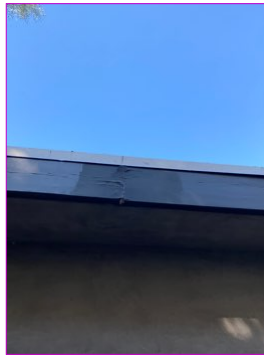
Moisture damage noted at right side fascia boards

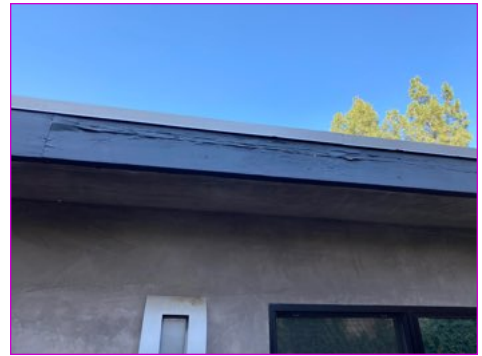
Moisture damage noted at the right side fascia boards

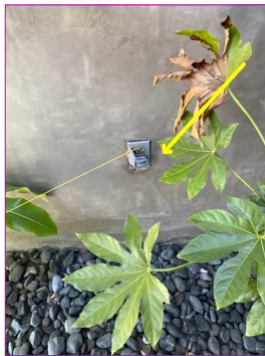
- Electrical outlet at the front left of entry way not functioning. We recommend having a qualified contractor evaluate and repair as needed.
- An exterior Ground Fault Circuit Interrupter (**GFCI**) electrical receptacle at the rear of the home did not respond to the test button. The Inspector recommends receptacle replacement as needed by a qualified electrical contractor.

Electrical outlet at the front left of entry way not functioning.

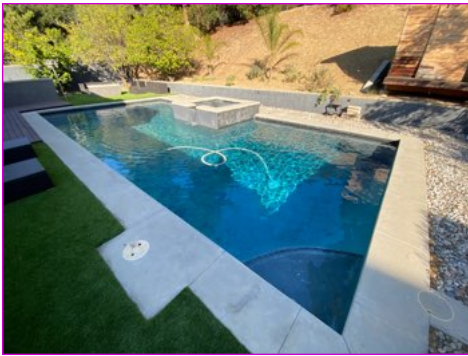
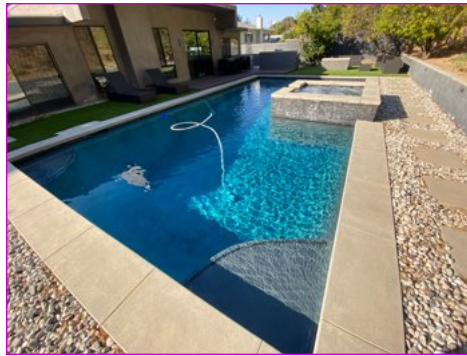
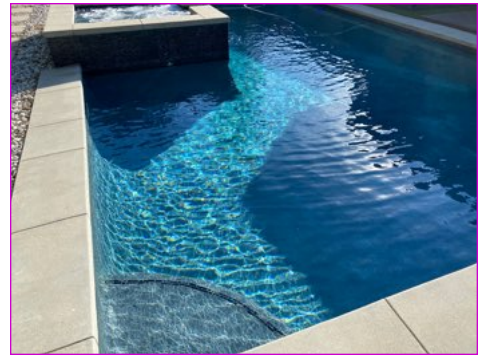
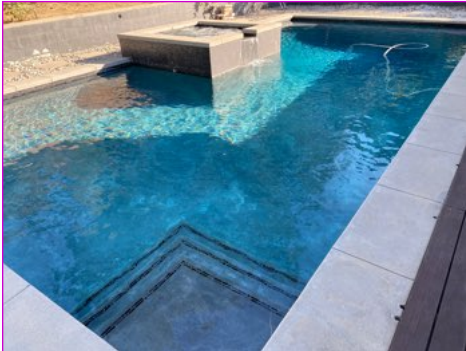
- The pool appeared to have chemical damage resulting in fading of the portions exposed to water. The Inspector recommends that before the expiration of your Inspection Objection Deadline you consult with a qualified contractor to discuss options and costs for actions that will reduce continuing damage.
- The hot tub had missing tiles. The Inspector recommends repair by a qualified swimming pool contractor.

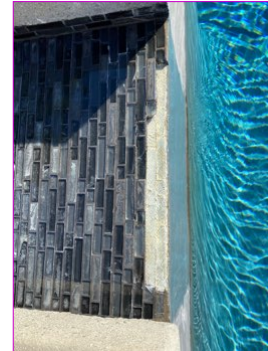
*Tile damaged at hot tub*

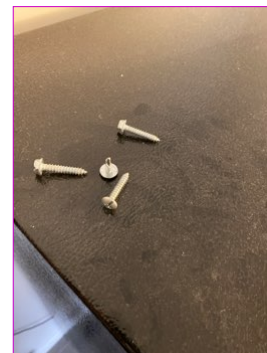
*Improper screws*

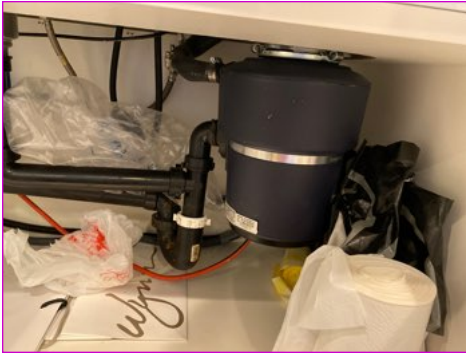
- At the time of the inspection, the Inspector observed few deficiencies in the condition and operation of the garbage disposal. Notable exceptions will be listed in this report.
- Disposal under kitchen sink was not functioning at the time of inspection. We recommend having a qualified contractor evaluate and repair as needed.

*Disposal under kitchen sink was not functioning at the time of inspection.*

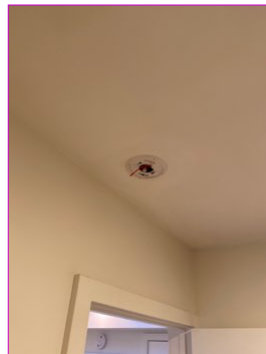
*Smoke alarm missing*

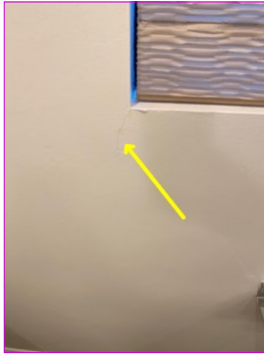
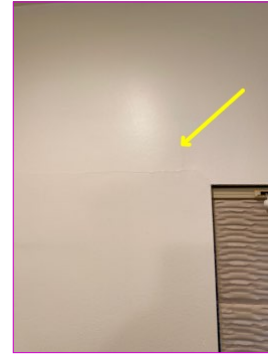
- At the time of the inspection, the Inspector observed few deficiencies in the condition of the bathroom walls. Any exceptions will be listed in this report.
- Minor cracks at the corners of doors and windows in walls in this bathroom appeared to be the result of long-term settling. Some settling is not unusual in a home of this age and these cracks are not a structural concern.

*Corner cracking noted at window*

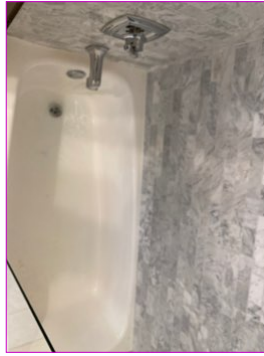
- Functional flow;
- Functional drainage; and
- Operational shut-off valves, faucet, and diverter valve.
- The tub had functional drainage.
- The tub had functional flow.
- **The tub in this bathroom had an inoperable stopper.**

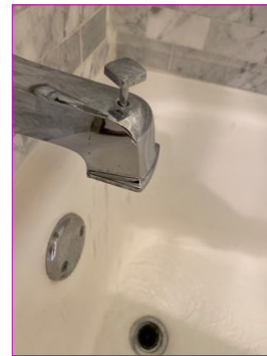
- The shower in this bathroom appeared to be in serviceable condition at the time of the inspection. Inspection of the shower typically includes:
  - Functional flow;
  - Functional drainage
  - Proper operation of shut-off and diverter valves, and faucet; and
  - Moisture intrusion of walls and pan.
- The shower had functional drainage at the time of the inspection.
- The shower had functional flow at the time of the inspection.
- In this bathroom, the diverter valve was inoperable or did not operate correctly (the diverter is the valve which diverts water from the tub faucet to the shower head). The inspector recommends service by a qualified plumbing contractor.

*Diverter valve did not fully engage*
