# *RND Home Inspections, LLC.*

## Property Inspection Report

1234 RND Home Inspection Way, Malibu, CA 90265

General, pool, and sewer inspection

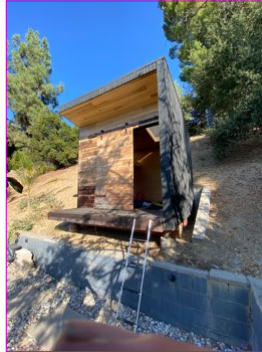
- Shed building on the rear of property was built using questionable building practices as well lacked proper stairs to access. We recommend having a the structure evaluated and repaired as needed.

*Shed*

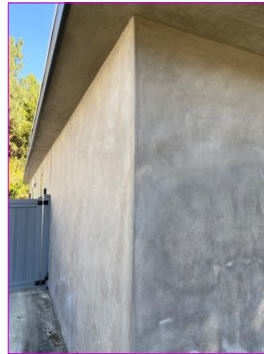
• The stucco covering exterior walls showed widespread moderate cracking. This type of cracking, called "thermal cracking" is a reaction to internal stresses created by stucco expansion and contraction caused by daily and seasonal temperature changes. This condition is made worse over time by exposure to moisture. Cracks exceeding 1/16-inch in width should be filled with an appropriate material to minimize future damage. Thermal cracking is common as stucco ages and minor cracks are a cosmetic concern. This type of cracking can be expected to continue slowly over time.

*Cracks in exterior wall*

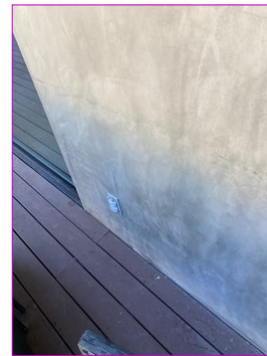
- Electrical outlet at the front left of entry way not functioning. We recommend having a qualified contractor evaluate and repair as needed.
- An exterior Ground Fault Circuit Interrupter (**GFCI**) electrical receptacle at the rear of the home did not respond to the test button. The Inspector recommends receptacle replacement as needed by a qualified electrical contractor.

Electrical outlet on the rear of home was not gfcI protected

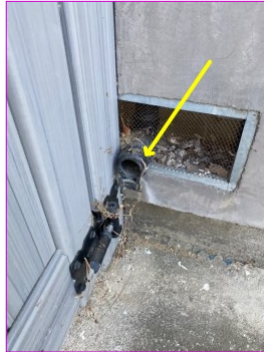
- Plumbing drain cap damaged/missing at the left side of home. We recommend having a qualified contractor repair as needed.

*Plumbing drain cap damaged/missing at the left side of home.*

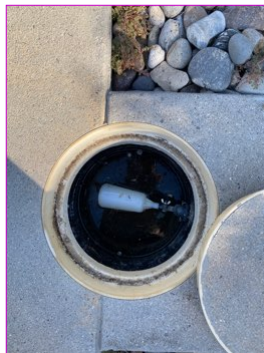
- The pool appeared to be filled to capacity at the time of the inspection.
- Auto fill device did not function properly at the time of inspection. We recommend having a qualified contractor evaluate and repair as needed.

*Auto fill device did not function properly at the time of inspection.*

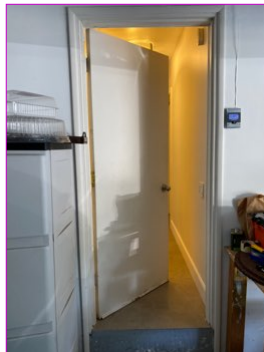
- The door in the wall between the garage and the home living space did not have operable self-closing hinges as is required by generally-accepted current safety standards.

*Garage house door missing auto closure hinges*

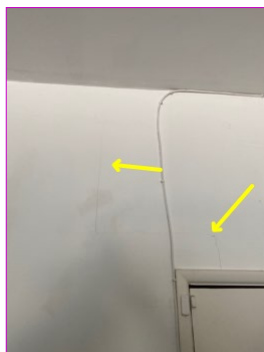
- The garage walls had damaged/ cracked drywall. The damage is presumably caused by foundation settlement. We recommend having a qualified contractor evaluate and repair as needed.

*Cracks noted in drywall*

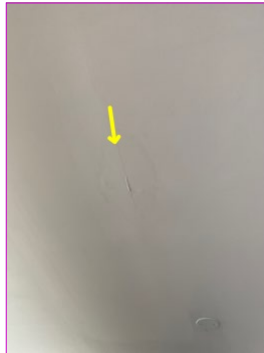
- Moisture staining noted at the garage ceiling. The damage appears to have been caused by a possible roof leak. We recommend having a qualified contractor evaluate and repair as needed.

*Moisture staining noted at the garage ceiling.*

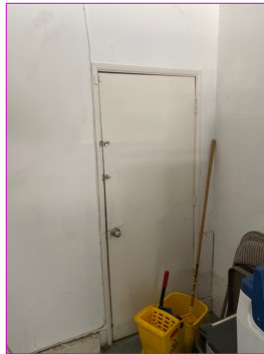
- Garage exterior door is visible out of square. This is causing difficulties opening and closing the door. We recommend having a qualified contractor evaluate and repair as needed.

*Garage exterior door is visible out of square*

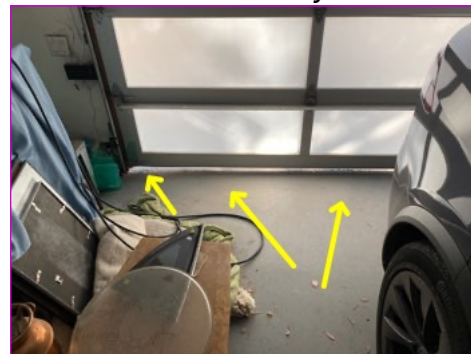
- At the time of the inspection, the Inspector observed few deficiencies in the condition of the overhead vehicle doors. Notable exceptions will be listed in this report.
- At the time of the inspection, the the overhead garage door exhibited general minor deterioration commensurate with its age.
- Garage door does not seal at the base when closed. This will allow moisture and unwanted pet intrusions. We recommend having a qualified contractor evaluate and repair as needed.

*Garage door does not seal at the base when closed.*

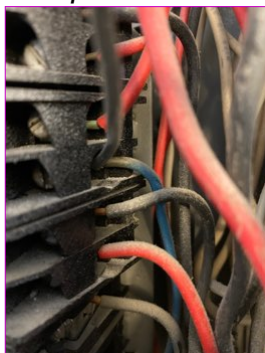
*Double tapped breakers*

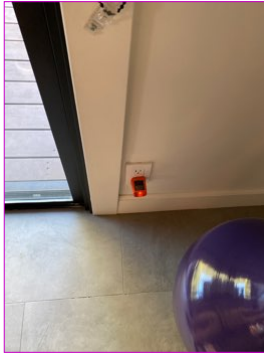
- Electrical outlet on the rear wall of living area near the sliding glass door and right side living area wall were wired with open ground wiring. We recommend having a qualified contractor evaluate and repair as needed.
- Electrical outlet on the right side living area wall was wired with open ground wiring. We recommend having a qualified contractor evaluate and repair as needed.

*Electrical outlet on the rear wall of living area near the sliding glass door wired with open ground wiring.*

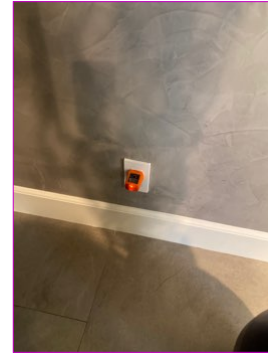
*Electrical outlet on the right side living area wall was wired with open ground wiring.*

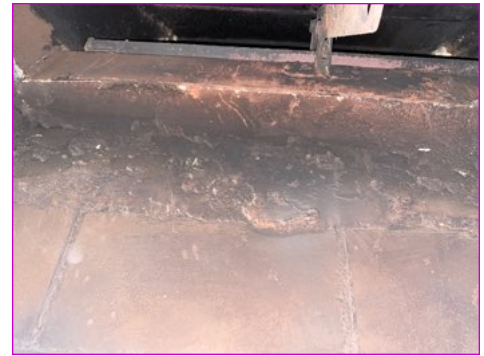
*Flue condition*

- The exhaust flue of the wood-burning fireplace appeared to need cleaning. Dirty flues are potential fire hazards.  
The flue should be cleaned by a qualified contractor.

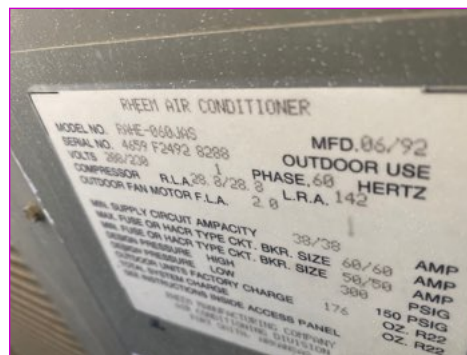
- Information from the air-conditioner label/data plate is shown in the photo.
- The air-conditioner date of manufacture appeared to be 1992.

*Product label*

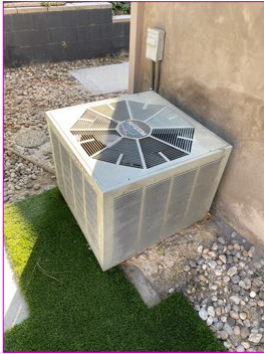
- The air-conditioning system appeared to be old but functioning as designed at the time of the inspection.

*Air conditioner condition*

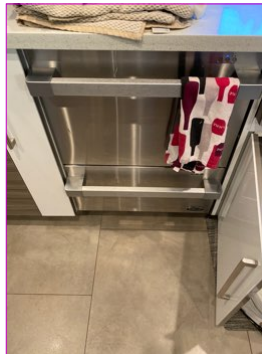
- At the time of the inspection, the Inspector observed no deficiencies in the condition and operation of the dishwasher. It was operated through a cycle.

*Dishwasher condition*

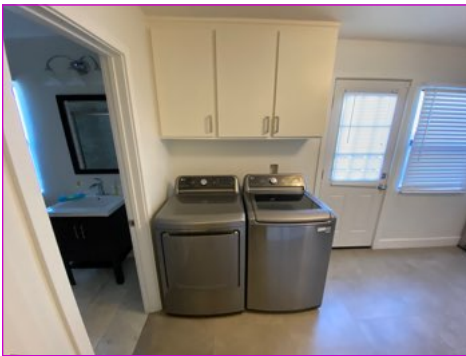
- At the time of the inspection, the Inspector observed no deficiencies in the condition of the laundry room.

*Laundry area*

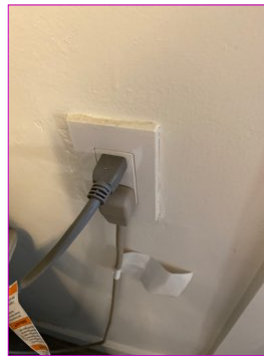
*Electrical outlet*

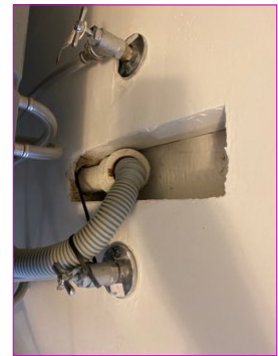
*Plumbing connectors*

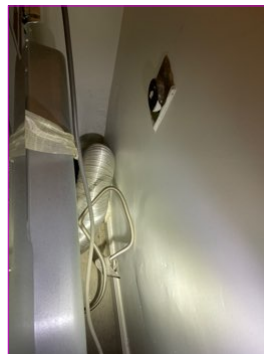
*Gas and vent pipe*

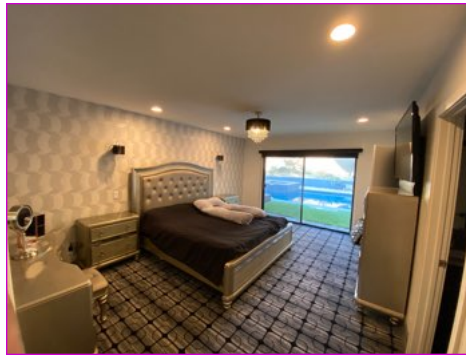
- At the time of the inspection, the Inspector observed no deficiencies in the condition of floors in this bedroom.

*Master bedroom condition*

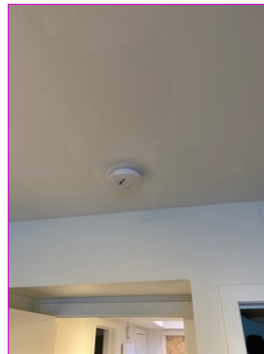
- A smoke detector in this bedroom needed repair / battery replacement at the time of the inspection. The Inspector recommends repair by a qualified contractor to ensure that the safest possible conditions exist.

*Smoke alarm missing battery*

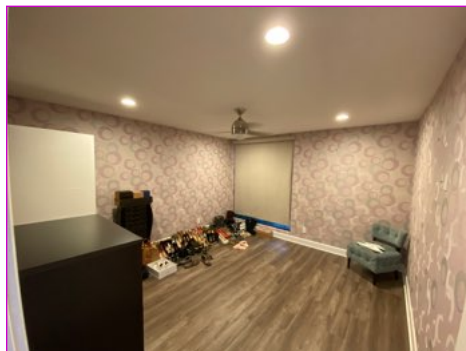
- At the time of the inspection, the Inspector observed no deficiencies in the condition of floors in this bedroom.

*Bedroom 1 condition*

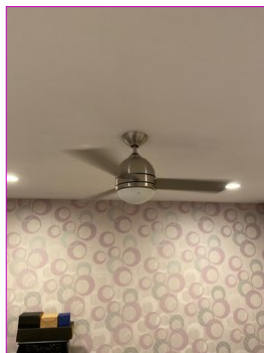
- All ceiling fans in the home were operable and appeared to be in serviceable condition at the time of the inspection.

*Ceiling fan condition*

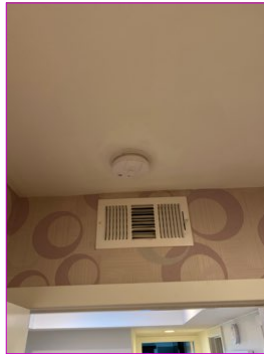
- Smoke alarm in place and functioning

*Smoke alarm in place and functioning*

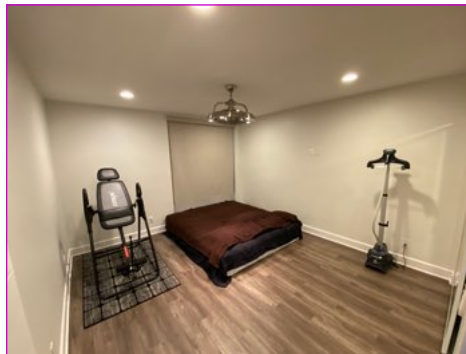
- At the time of the inspection, the Inspector observed no deficiencies in the condition of floors in this bedroom.

*Bedroom 2 condition*

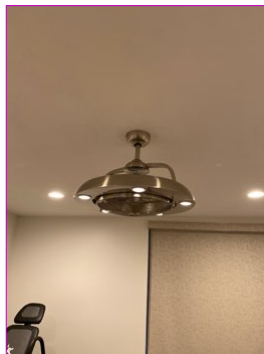
- All ceiling fans in the home were operable and appeared to be in serviceable condition at the time of the inspection.

*Ceiling fan condition*

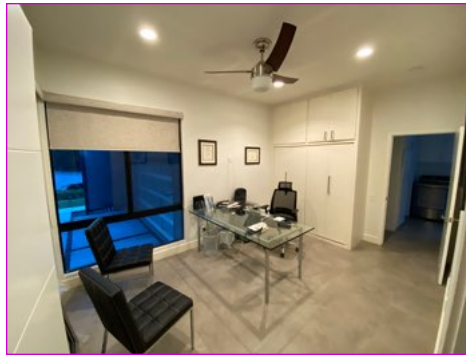
• At the time of the inspection, the Inspector observed no deficiencies in the condition of floors in this bedroom.

*Bedroom 3*

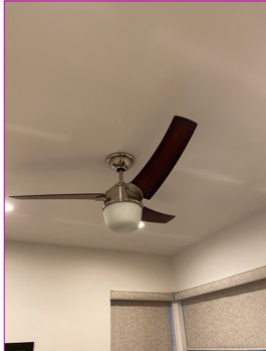
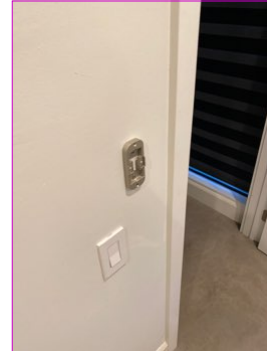
- All ceiling fans in the home were operable and appeared to be in serviceable condition at the time of the inspection.
- Ceiling fan operates by remote. The remote was not present at the time of inspection. We recommend replacing the remote and testing as needed to verify fan is in working condition

*Ceiling fan condition*

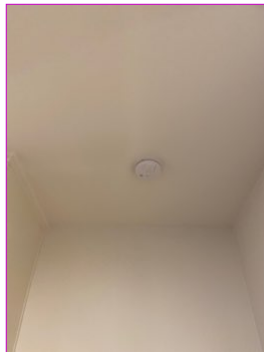
- Smoke alarm in place and functioning

*Smoke alarm in place and functioning*

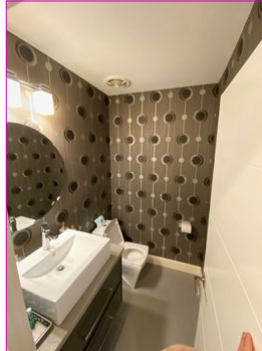
- At the time of the inspection, this bathroom exhibited general minor wear and deterioration commensurate with the age of the home.

*Entry bathroom condition*

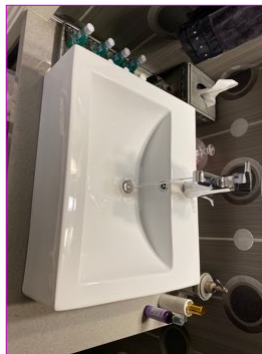
- At the time of the inspection, the Inspector observed no deficiencies in the condition of this bathroom sink.
- The bathroom sink had functional drainage at the time of the inspection.
- This bathroom sink had functional flow at the time of the inspection.

*Sink condition*

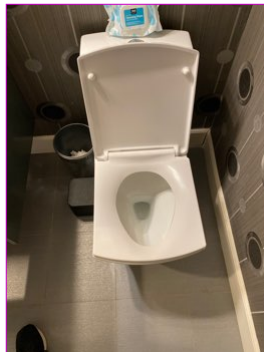
- This bathroom had a low-flow toilet installed that used a maximum of 1.6 gallons (6 liters) per flush.
- The toilet in this bathroom was flushed and operated in a satisfactory manner.

*Toilet condition*

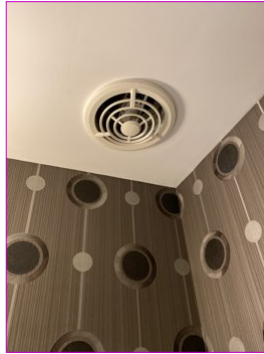
- This bathroom had an operable source of ventilation at the time of the inspection.

*Vent condition*

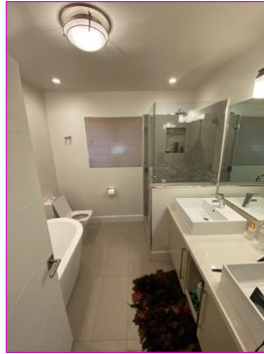
- At the time of the inspection, the Inspector observed no deficiencies in the condition of this bathroom.

*Main floor bathroom condition*

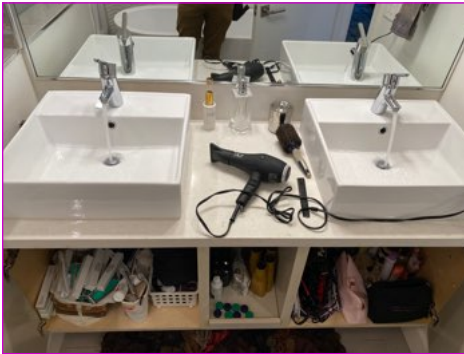
- Both bathroom sinks had functional flow and functional drainage.
- Both bathroom sinks had functional drainage at the time of the inspection.

*Sink condition*

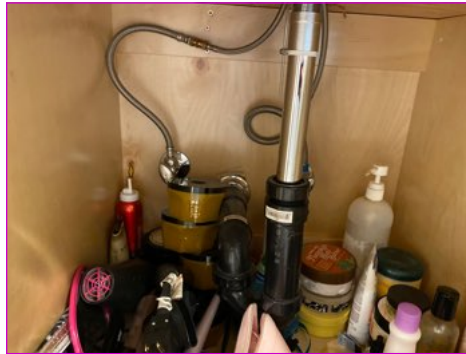
*Plumbing under sink on right*

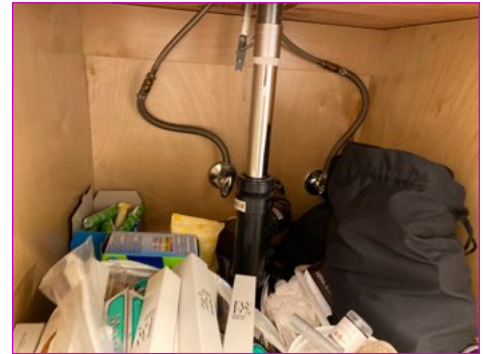
*Plumbing under sink on left*

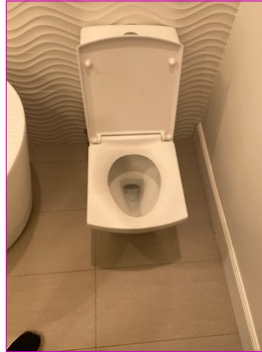
- This bathroom had a low-flow toilet installed that used a maximum of 1.6 gallons (6 liters) per flush.
- The toilet in this bathroom was flushed and operated in a satisfactory manner.

*Toilet condition*

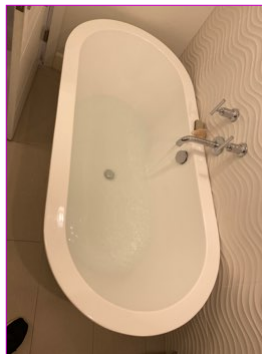
- Functional flow;
- Functional drainage; and
- Operational shut-off valves, faucet, and diverter valve.
- The tub had functional drainage.
- The tub had functional flow.

*Tub condition*

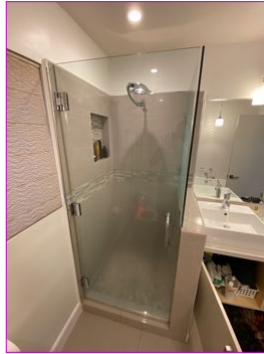
- The shower had functional drainage at the time of the inspection.
- The shower had functional flow at the time of the inspection.

*Shower condition*

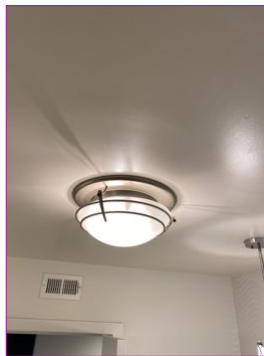
- This bathroom had an operable source of ventilation at the time of the inspection.

*Vent fan*

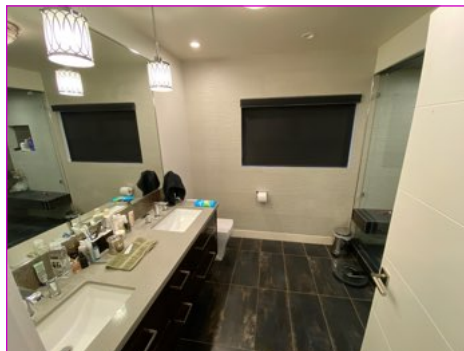
- At the time of the inspection, this bathroom exhibited general minor wear and deterioration commensurate with the age of the home.

*Master bathroom condition*

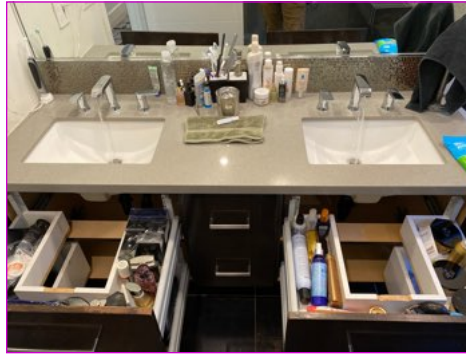
- At the time of the inspection, the Inspector observed no deficiencies in the condition of both bathroom sinks.
- Both bathroom sinks had functional flow and functional drainage.
- Both bathroom sinks had functional drainage at the time of the inspection.

*Sink condition*

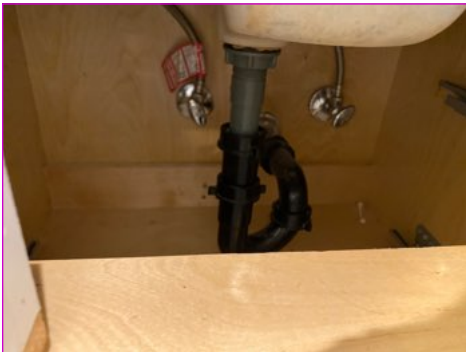
- At the time of the inspection, the Inspector observed no deficiencies in the condition and operation of undersink plumbing in the kitchen.

*Plumbing under left side sink*

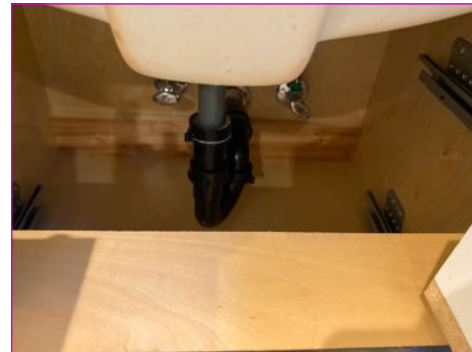
*Plumbing under right side sink*

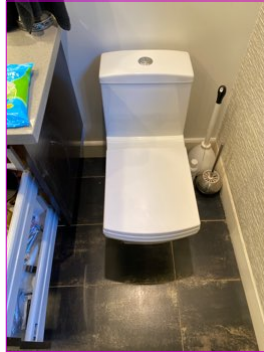
- This bathroom had a low-flow toilet installed that used a maximum of 1.6 gallons (6 liters) per flush.
- The toilet in this bathroom was flushed and operated in a satisfactory manner.

*Toilet condition*

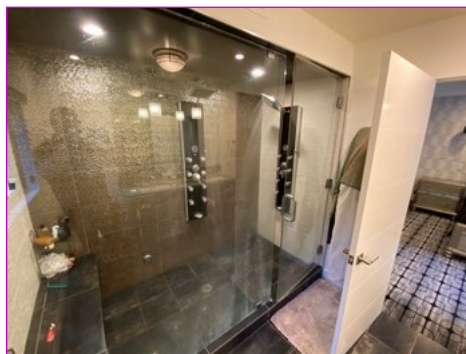
- The shower in this bathroom appeared to be in serviceable condition at the time of the inspection. Inspection of the shower typically includes:
  - Functional flow;
  - Functional drainage
  - Proper operation of shut-off and diverter valves, and faucet; and
  - Moisture intrusion of walls and pan.
- The shower had functional drainage at the time of the inspection.
- The shower had functional flow at the time of the inspection.

*Shower condition*

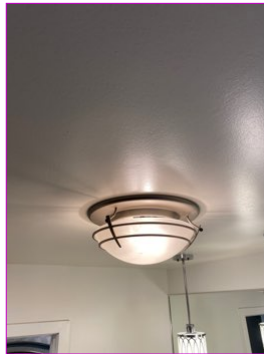
- This bathroom had an operable source of ventilation at the time of the inspection.

*Vent condition*

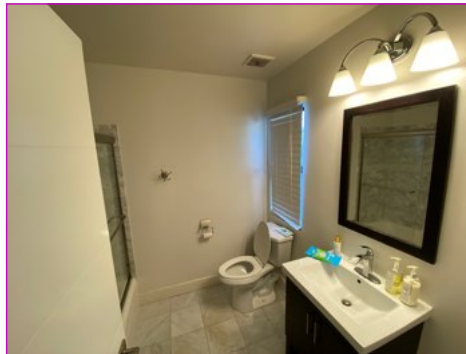
- At the time of the inspection, this bathroom exhibited general minor wear and deterioration commensurate with the age of the home.

*Laundry off bathroom*

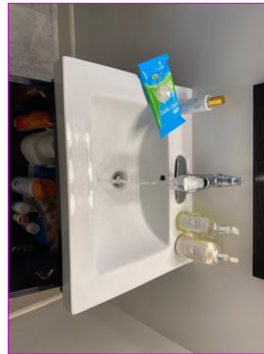
- At the time of the inspection, the Inspector observed no deficiencies in the condition of this bathroom sink.
- The bathroom sink had functional drainage at the time of the inspection.
- This bathroom sink had functional flow at the time of the inspection.

*Sink condition*

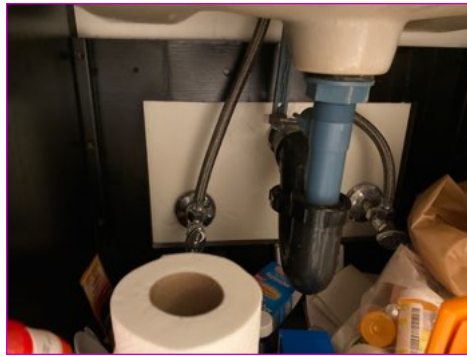
- At the time of the inspection, the Inspector observed no deficiencies in the condition and operation of undersink plumbing in the kitchen.

*Plumbing under sink*

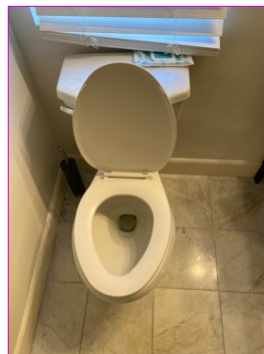
- This bathroom had a low-flow toilet installed that used a maximum of 1.6 gallons (6 liters) per flush.
- The toilet in this bathroom was flushed and operated in a satisfactory manner.

*Toilet condition*

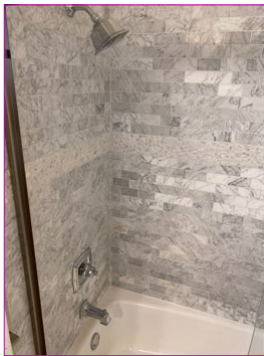
- The shower in this bathroom appeared to be in serviceable condition at the time of the inspection. Inspection of the shower typically includes:
  - Functional flow;
  - Functional drainage
  - Proper operation of shut-off and diverter valves, and faucet; and
  - Moisture intrusion of walls and pan.
- The shower had functional drainage at the time of the inspection.
- The shower had functional flow at the time of the inspection.
- In this bathroom, the diverter valve was inoperable or did not operate correctly (the diverter is the valve which diverts water from the tub faucet to the shower head). The inspector recommends service by a qualified plumbing contractor.

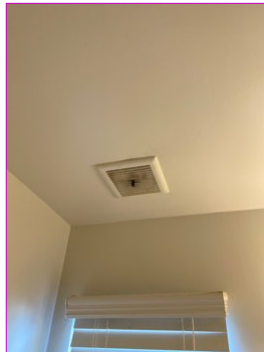
- This bathroom had an operable source of ventilation at the time of the inspection.

*Vent condition*
